**A FORWARD THINKING BUILDING CONSULTANCY  
BASED IN THE HEART OF NORTH WALES**

JDS Consulting  
CHARTERED SURVEYORS

**KAIZEN**  
Consulting Engineers

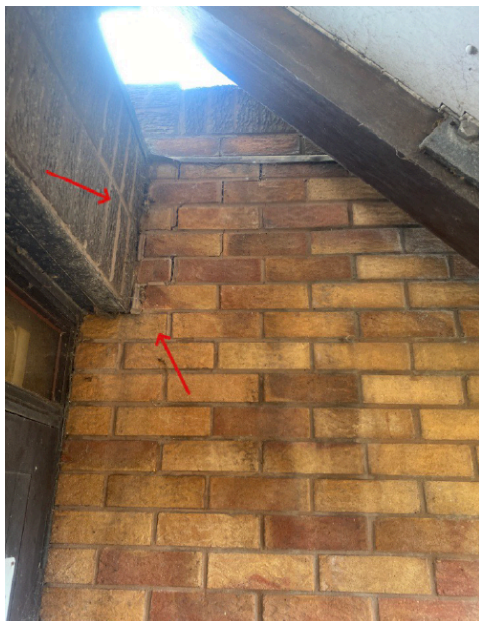
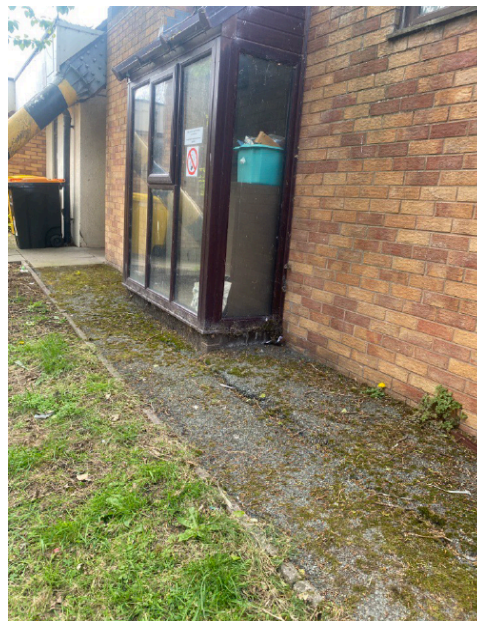
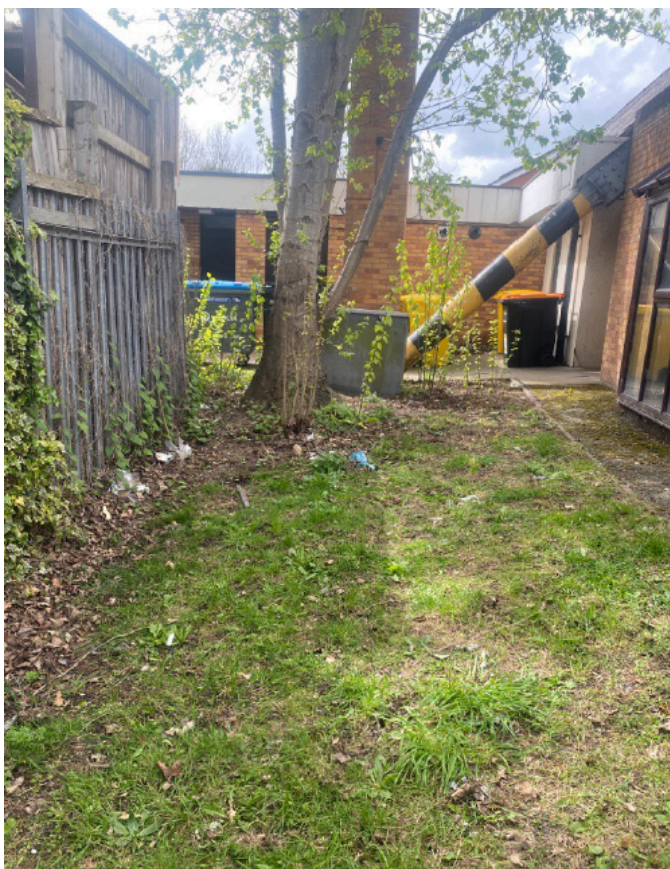
*Observations*

The principal structural item of note is the slight lean to the masonry boiler flue tower at the south-eastern corner of the site. This appears likely to be associated with historic localised settlement, potentially influenced by adjacent mature vegetation, ground moisture variation and local soil conditions. Associated minor cracking and localised settlement were also noted to adjacent masonry, tarmac and concrete edging. No evidence of acute instability was observed, but this area should be monitored and reviewed alongside a tree/arboricultural assessment and any required vegetation management.

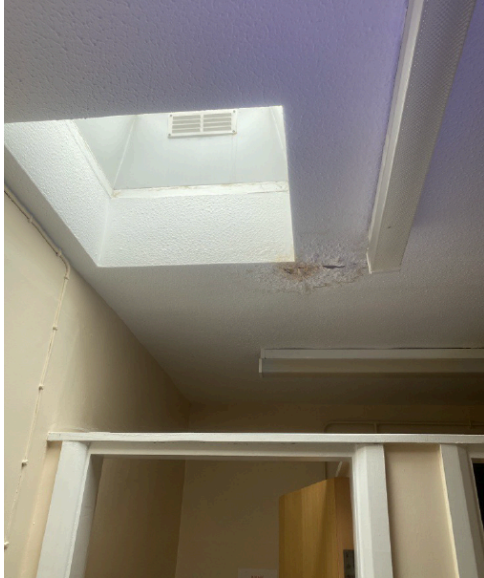
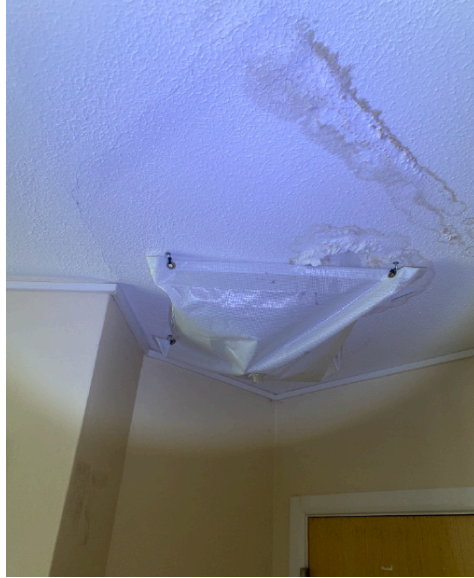
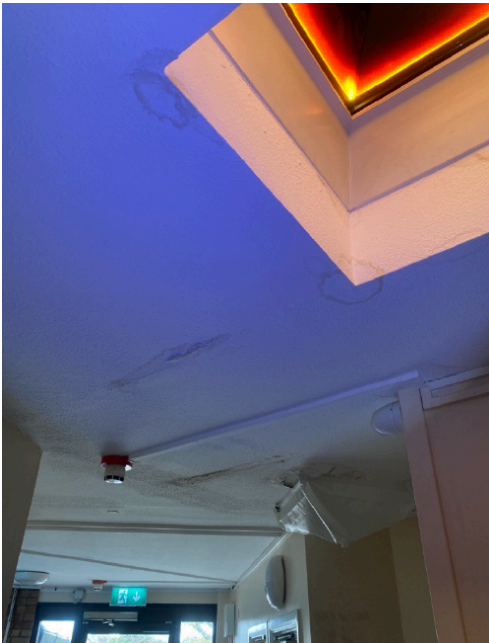
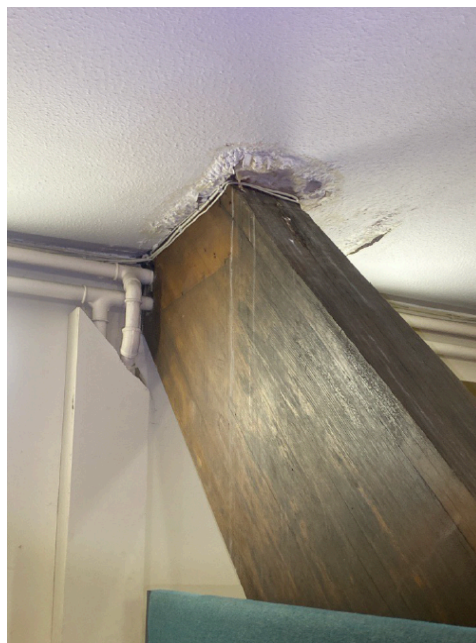
#### *Observations*

coverings, shrinkage to the waterproof membranes and inadequate lapping details surrounding rooflight and skylight interfaces.

Immediate consideration should therefore be given toward repairing the defective flashing arrangements, improving drainage detailing to the tower intersection and removing saturated and deteriorated deck materials within the affected void.

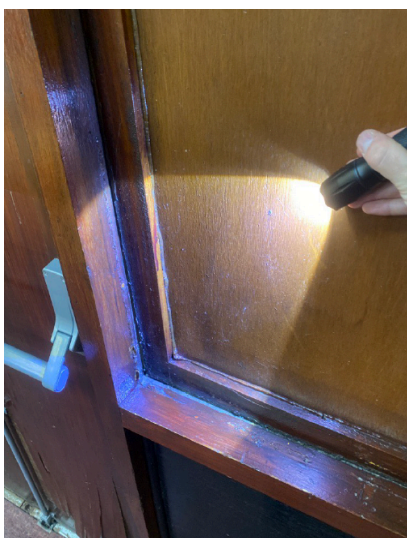
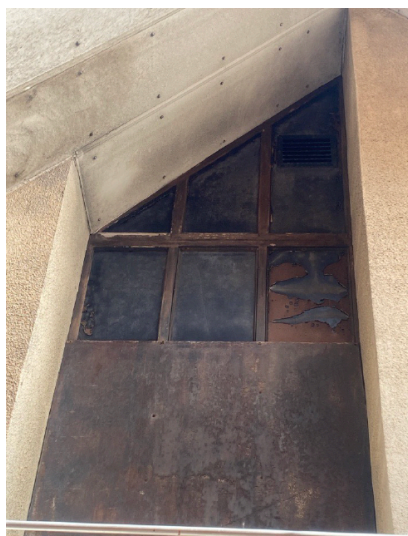
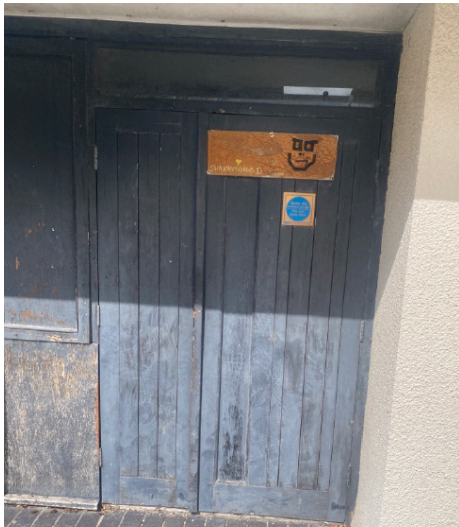
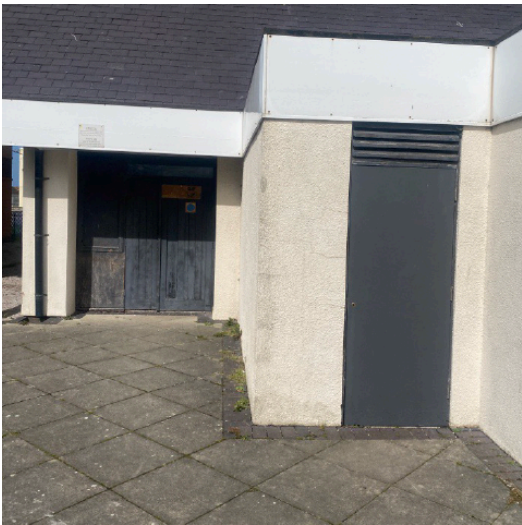
#### **Observations**

Particular concern relates to a blocked-up door opening positioned toward the south-western corner of the community building. The existing infill arrangement appears poorly constructed and inadequate from a security perspective. During inspection, sections of the infill were capable of being manually displaced, allowing visibility and partial access into the building interior. Given the location of this elevation adjacent to public realm areas and the potential security implications associated with unauthorised access, this defect should be regarded as a significant security concern. It is therefore recommended that a suitable industrial-grade security door or equivalent robust infill construction is installed within this location in order to properly secure the building envelope.

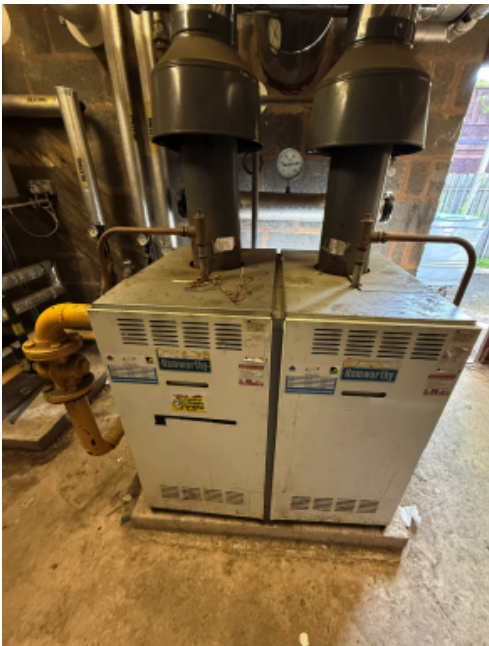
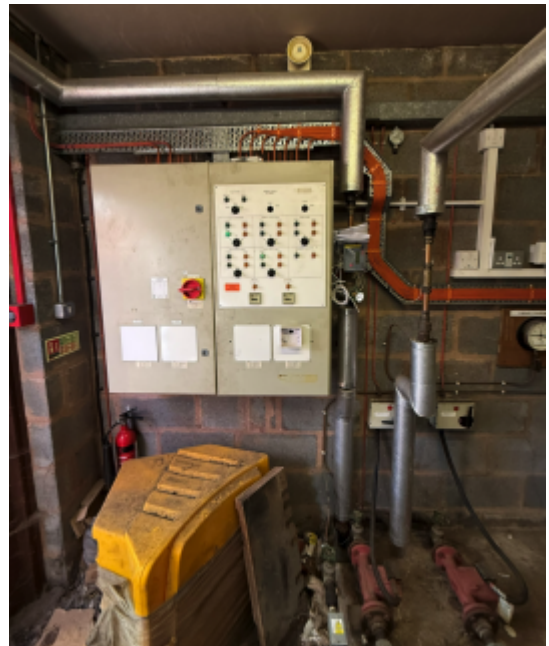
***Mechanical Control Panel & Hamworthy UR Series Boilers - Open Flues***

The inspection also identified that the masonry chimney structure associated with the boiler flue installation exhibits signs of slight lean/distortion. Whilst no immediate evidence of structural instability or imminent failure was noted, the condition of the chimney should be monitored and reviewed as part of future structural and external fabric maintenance strategies, particularly given its role in safely discharging combustion gases from the boiler plant.

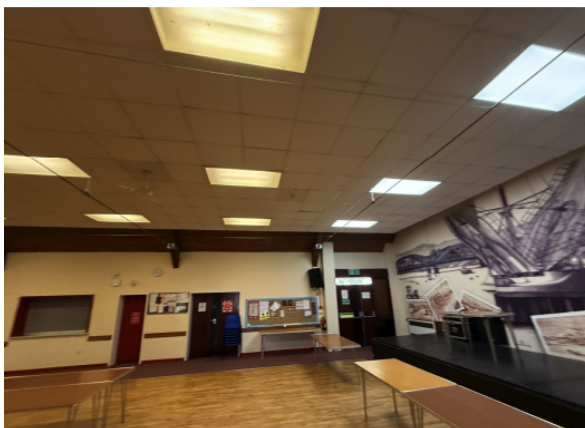
The emergency lighting installations also appear to have undergone ad hoc modifications and localised replacement works throughout the building's life. While the systems may remain broadly functional, concerns remain regarding consistency of coverage, escape route illumination and overall compliance provision throughout the wider property. Accordingly, a full emergency lighting compliance assessment should be commissioned, together with phased upgrading works where deficiencies are identified.

*Variance in lighting types - Community Hall Example*

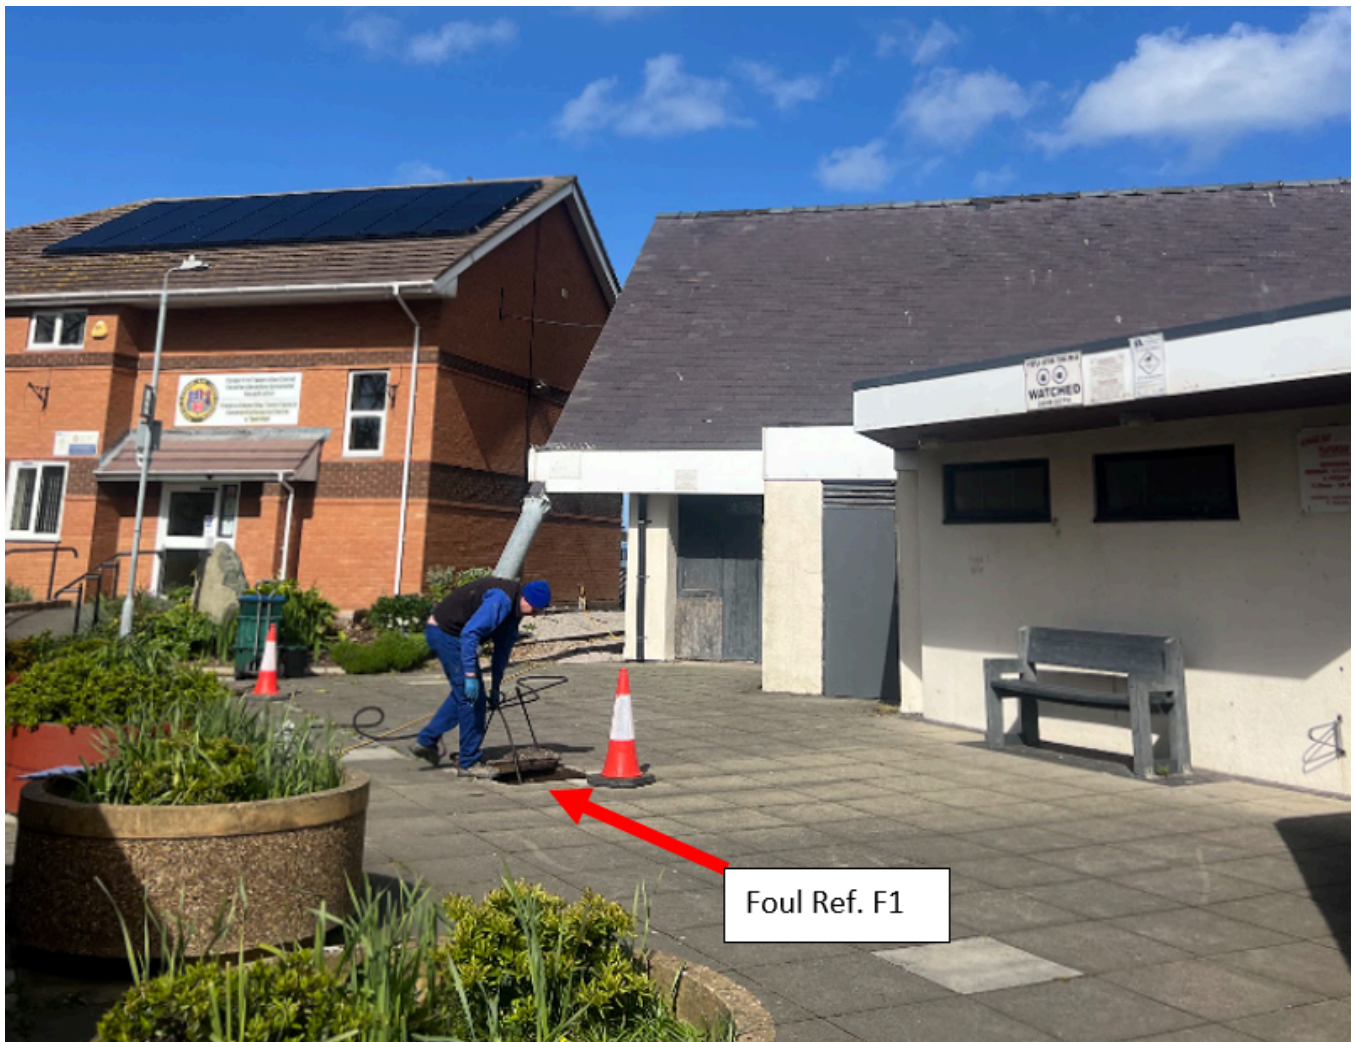
### *Foul Drainage Inspection - Ref F1*

The inspected pipework is understood to comprise predominantly 100mm vitrified clay foul drainage pipework, typical of buildings of this age and nature.

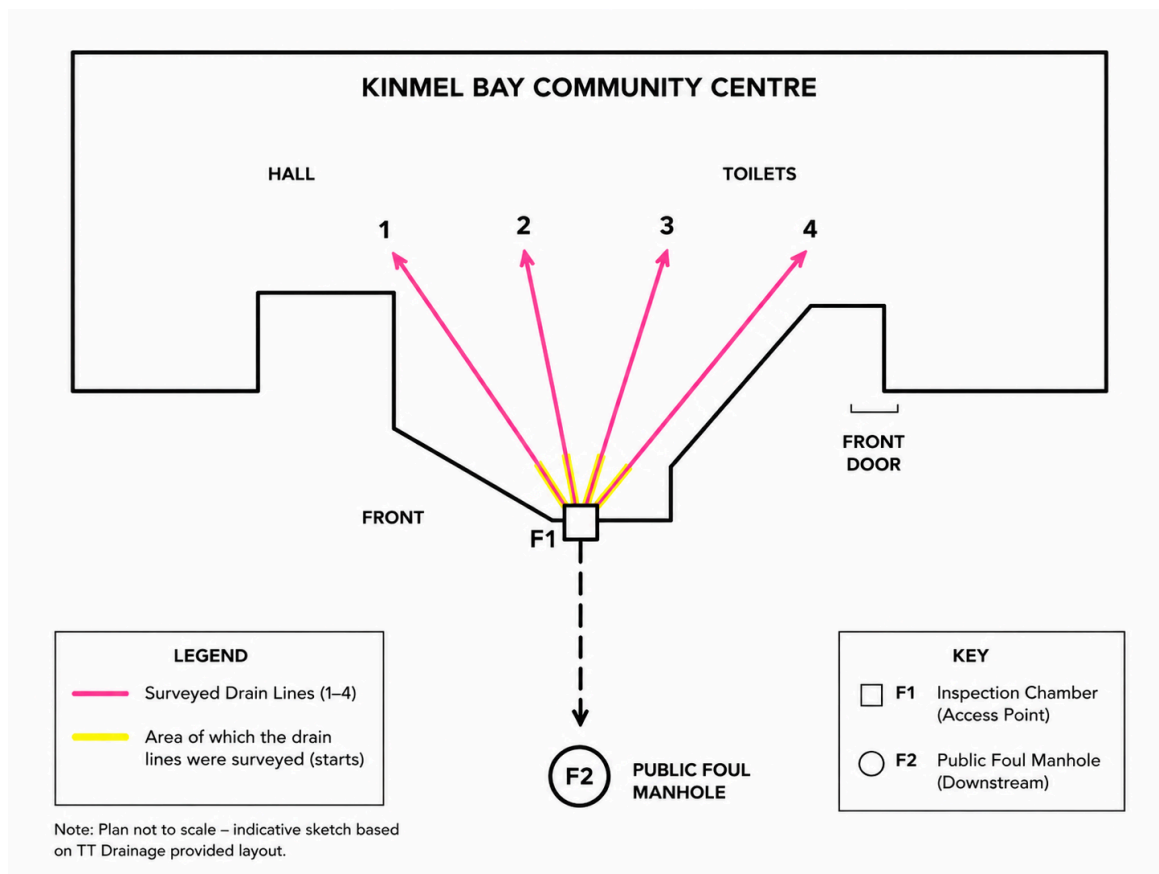
#### *Foul Drainage Inspection- Drainage Plan*

Survey runs identified as "Survey 1" and "Survey 2" were generally found to be in comparatively good condition, with only minor observations noted. Survey 1 identified a medium-grade displaced joint located approximately 0.89m along the surveyed run, although no immediate evidence of major failure or obstruction was identified in this section.

Survey 2 was found to be generally serviceable overall with no significant structural defects identified during the CCTV inspection.
