# Arboricultural Impact Assessment

Former Public Toilets, Towyn BS5837 AIA

**NWTC\_25\_13\_SA\_BS5837\_AIA**

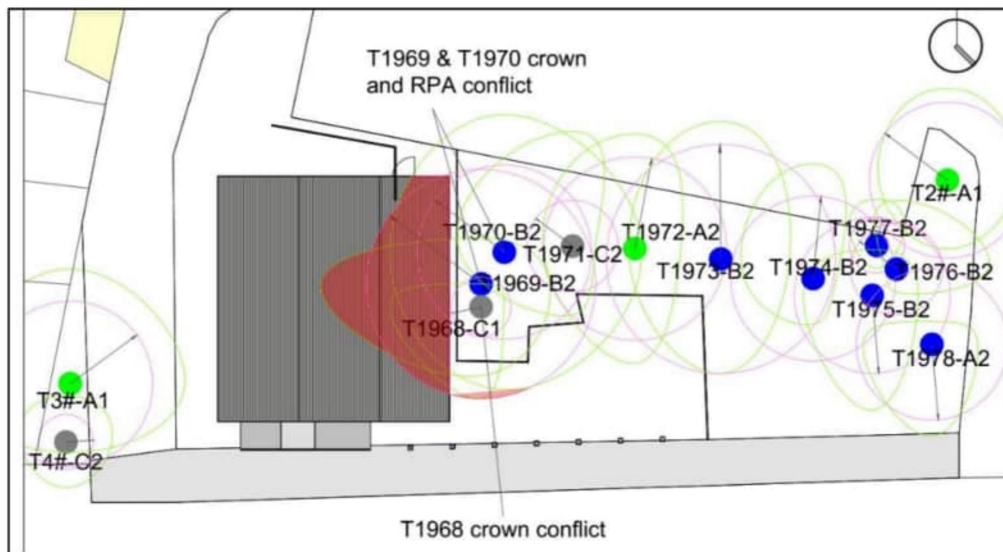
Figure 4 Excerpt from TCP2 showing above and below ground conflicts with the proposed design

The proposed design conflicts with the tree crowns of T1968-1970. To retain these trees, the tree crowns would require heavy pruning to facilitate the construction of the extension. The position of the trees relative to the proposed design means that the trees will require ongoing management in the long term to mitigate conflict with the building fabric.

The proposed design foundations conflict with the RPA of T1969 by 32% & T1970 by 13%. Under the British standard, the incursion into the RPA has to stay under 20%. Furthermore, a practical working space is required to construct the extension.

The conflicts can be mitigated for through a heavy crown reduction of the trees. This would stress the trees and leave the trees looking unsightly, and does not address the issue of the tree stems so close to the proposed building elevation. The RPA conflict can be mitigated by constructing the building on pile and beam foundations. However, given the location of the trees relative to the proposed building elevation, they will continue to be a management concern. Also, the scale of the development is such that it is more practical in the long term to remove the trees to avoid future management complications and enable an easy construction process. There is sufficient space on the site to compensate for the loss of these trees along the northwest boundary, where the TPO G1- originally 5 trees now only 1 – is located (ref figure 3). T1969 and T1970 are semi-mature oaks in good condition category B2, while it is undesirable to remove trees in good condition, they are still relatively juvenile and can be easily replaced on the site. T1968 is a hawthorn in poor condition, category C2 and under the standard can be justifiably removed.

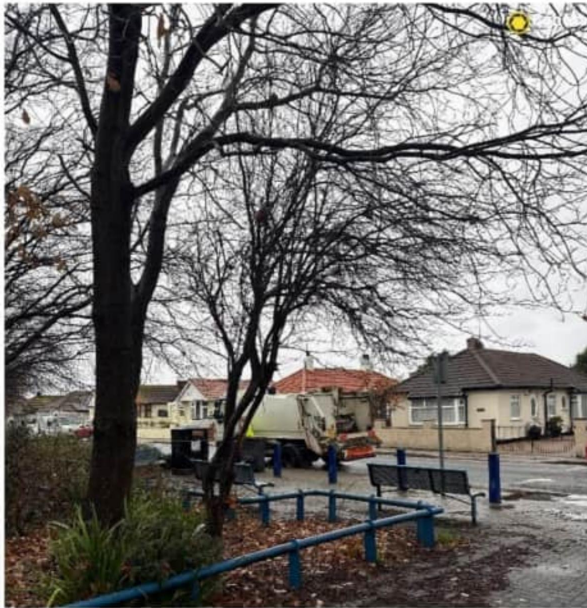
### 4.6.1 T1968 Hawthorn C2

Subdominant tree in poor condition, conflicting with the proposed building footprint. Remove and replace.

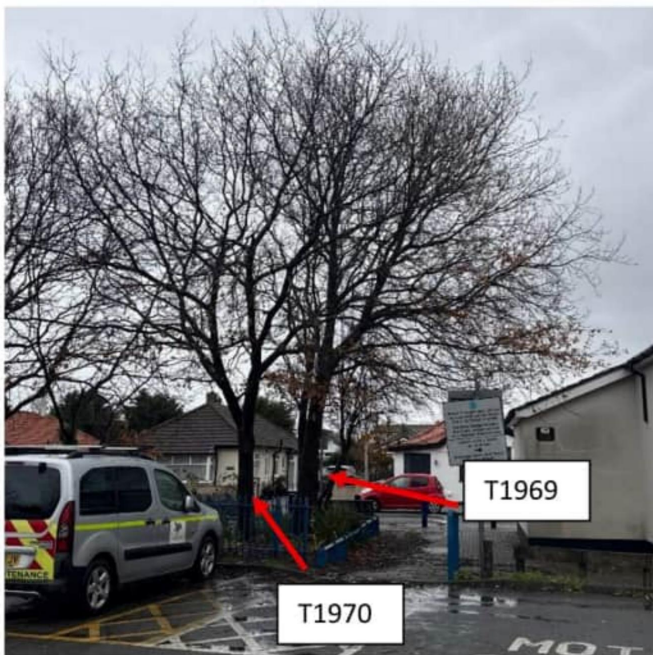
### 4.6.2 T1969 & T1970 Oak B2

2 Semi-mature oaks in good condition conflicting above and below ground with the proposed building footprint and practical construction space. Remove and replace
