**A FORWARD THINKING BUILDING CONSULTANCY  
BASED IN THE HEART OF NORTH WALES**

JDS Consulting  
CHARTERED SURVEYORS

**KAIZEN**  
Consulting Engineers

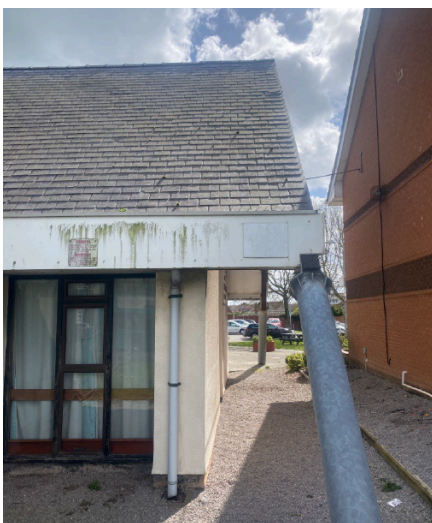
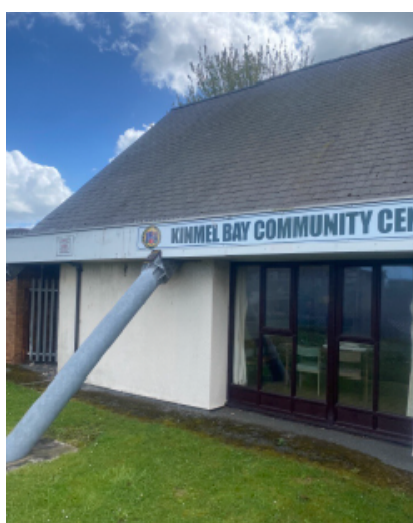
#### *Form of Construction*

No intrusive structural investigations were undertaken as part of this commission and therefore concealed structural elements remain outside the scope of direct inspection. Nevertheless, based upon visual assessment of accessible areas, the principal structure is considered capable of continued serviceable performance subject to ongoing maintenance and targeted remedial intervention.
