## Sandy Cove Overtopping 9 April 2024

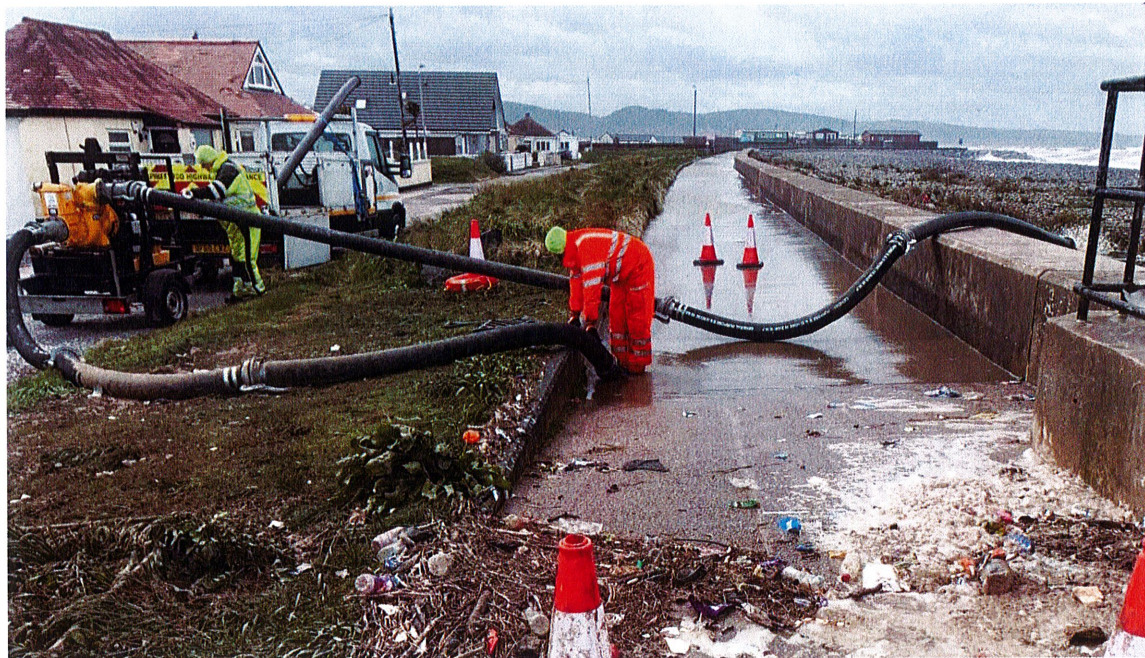
CCBC officers pumped overflow water from the prom as before the prom was blocked by the access ramps without effective drainage.

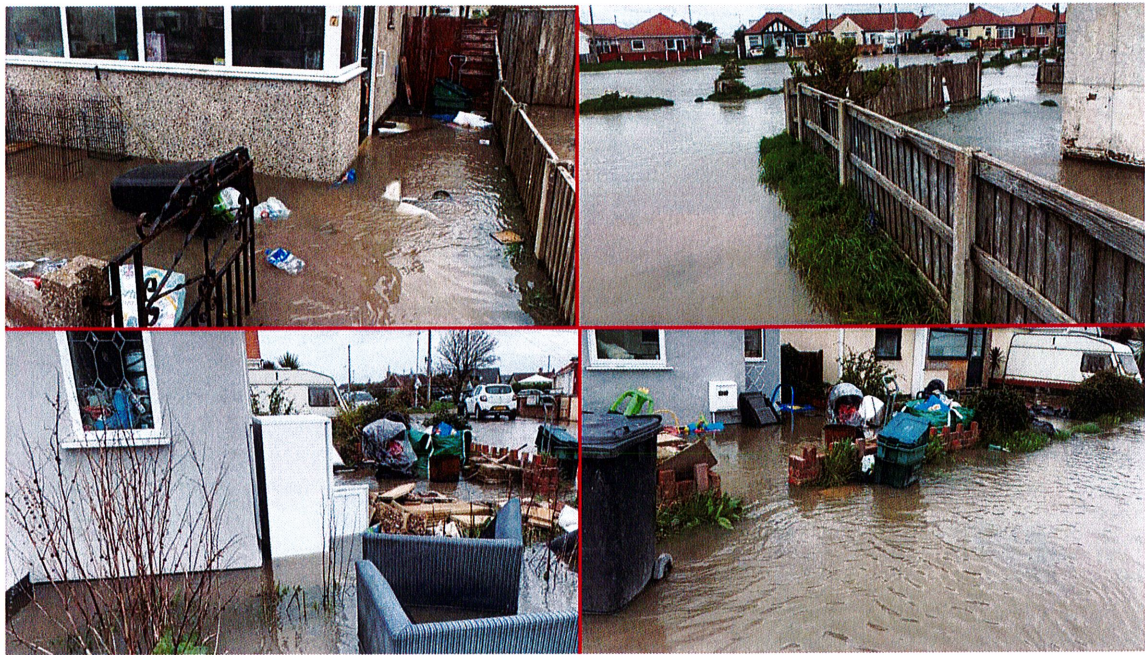
Property in Clwyd and Alyd Gardens were in some cases flooded to just under floor level. A half hour flooding of premises can result in insurance claim and flood damage repair with residents in stressful temporary accommodation for months.

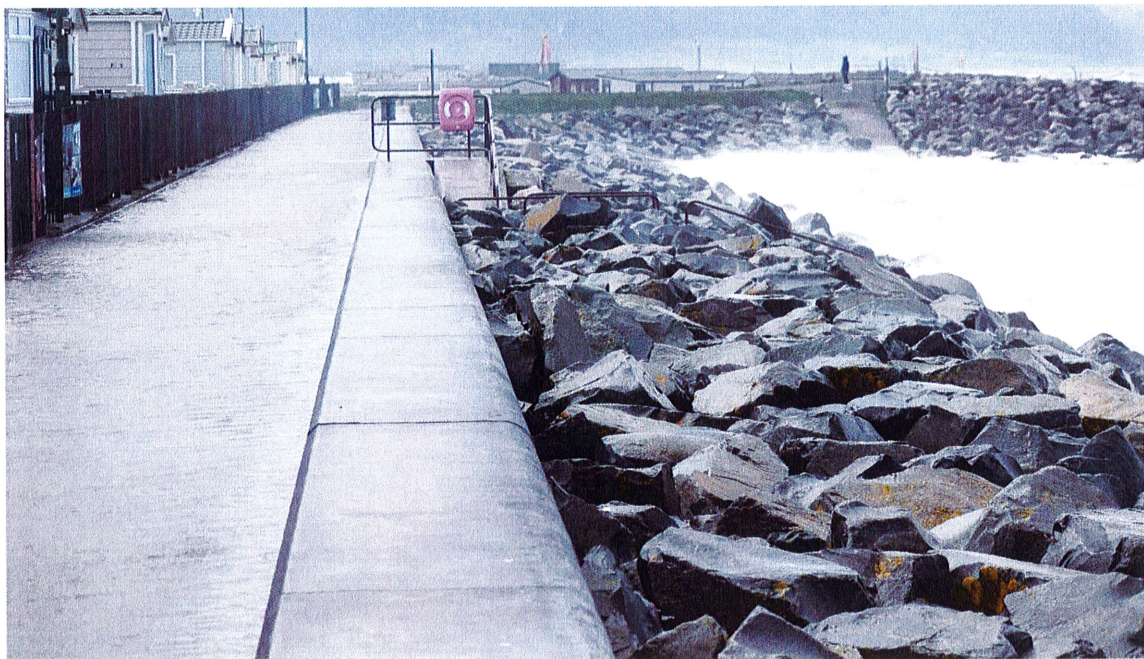
Waves breaking over steep rock armour revetment along the coast facing caravan park then drains sea water across the prom and through the caravan park to flood residential property in Sandy Cove from the rear.

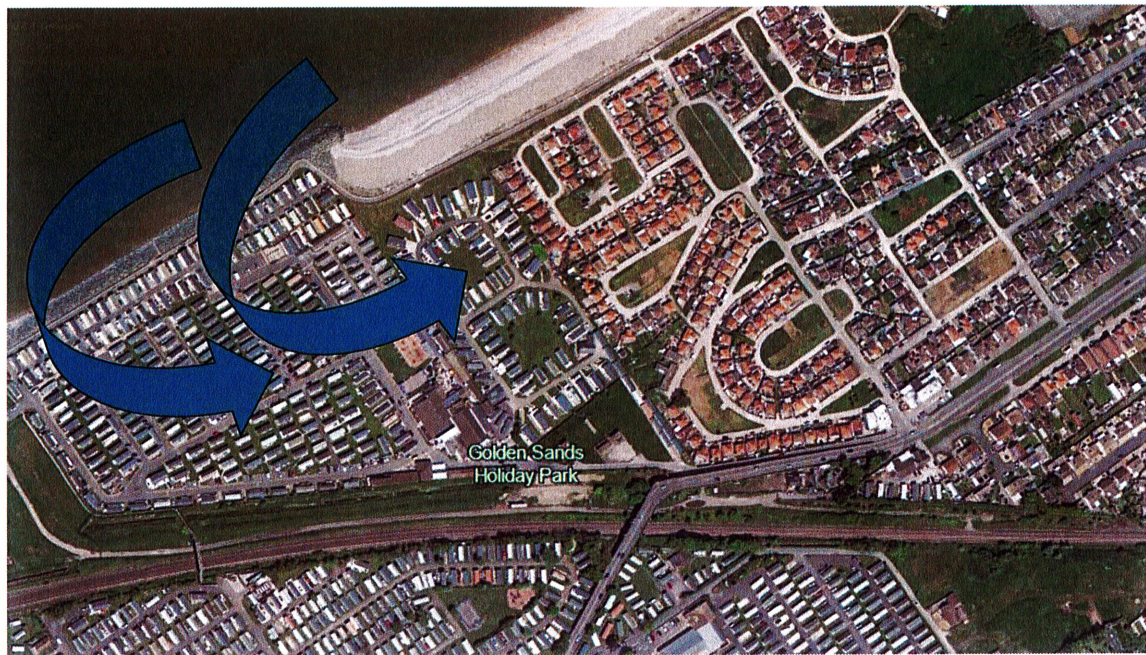
Overtopping sea water appears to run across the shallow inner wall in front of Golden sands, through the caravan park and into Sandy Cove property backing.

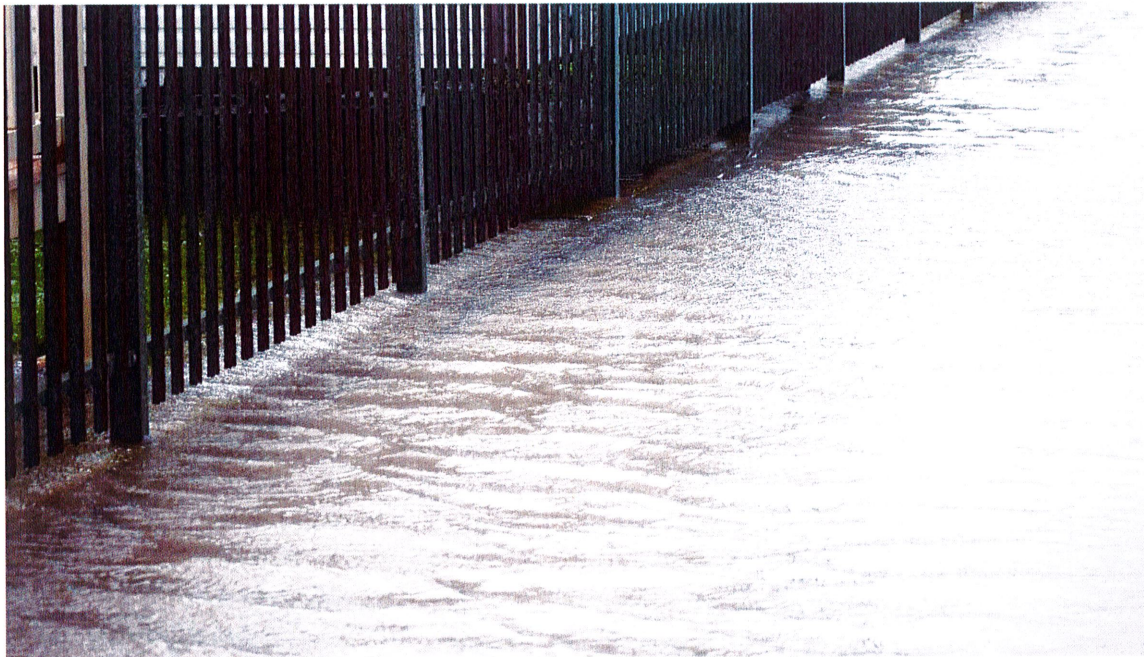
The inner wall is very low along this frontage.

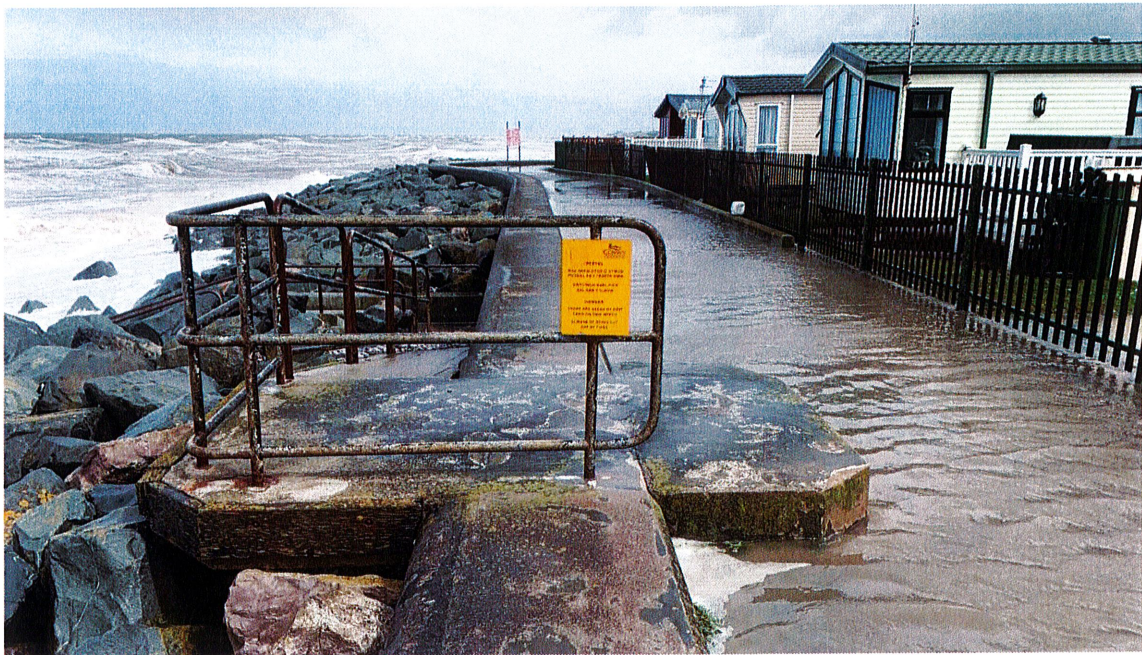
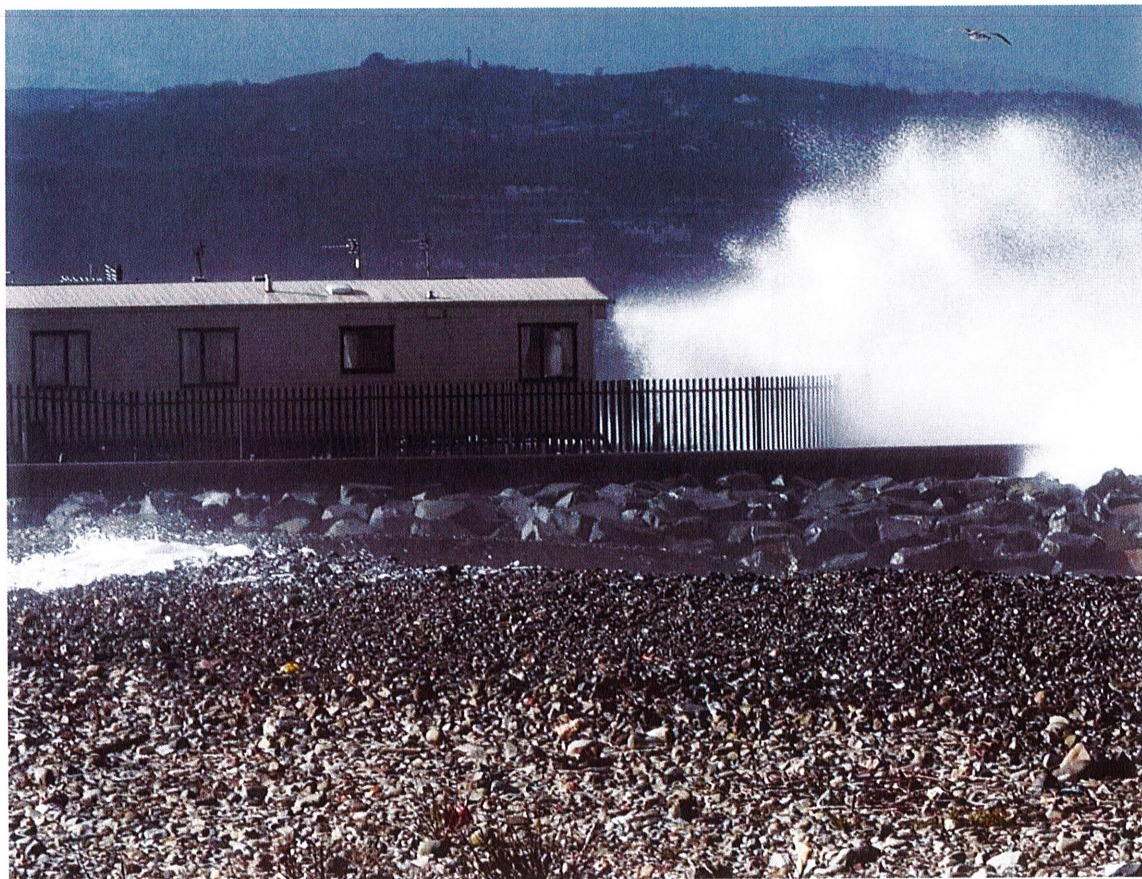
Sea water floods across the prom. It is difficult to see how a metre on the wall would stop this flooding (previous example below).

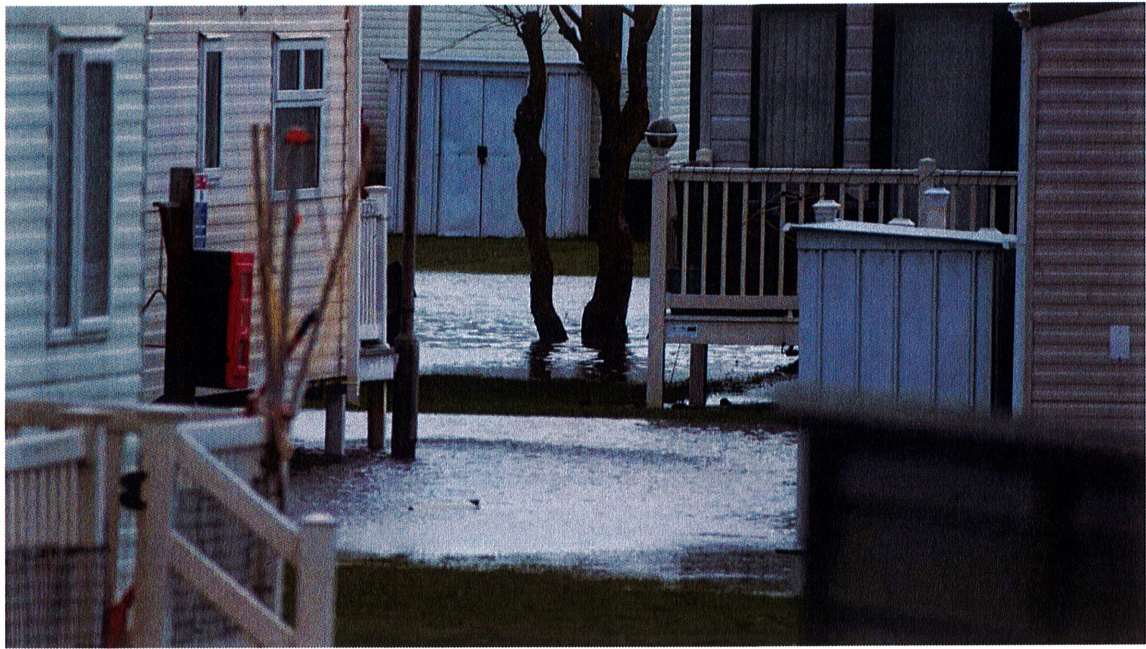
After high tide water can be seen flowing through Golden Sands from prom towards Sandy Cove.

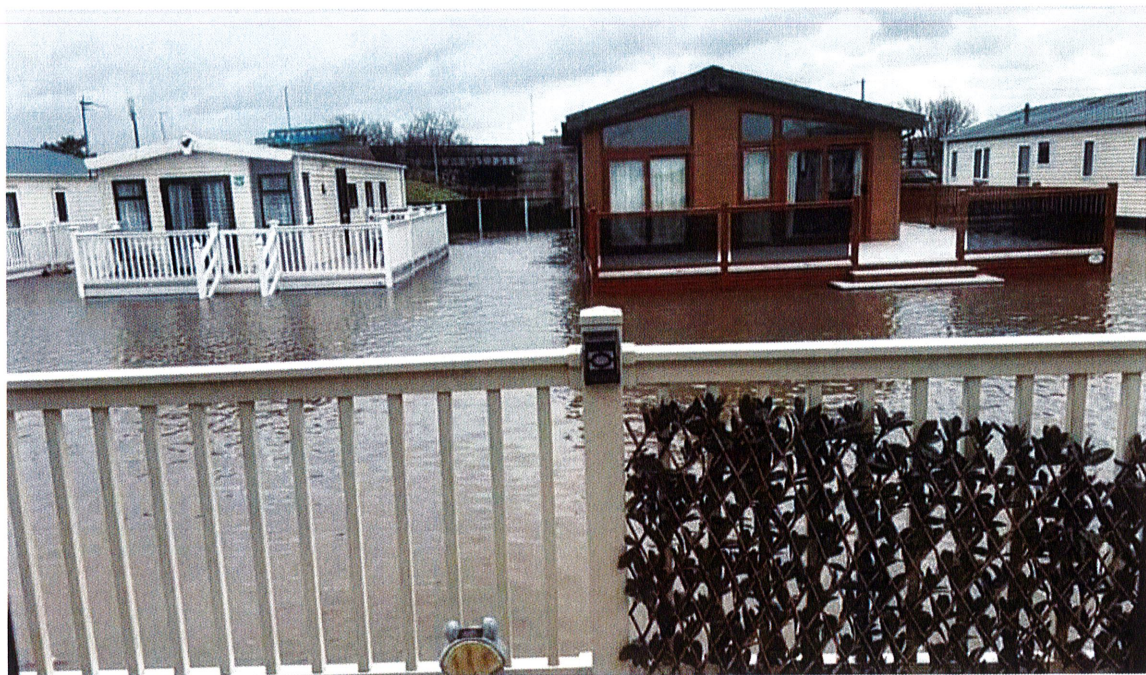
Social media shot showing flood level inside the park, to flow through and flood Cove residents.
